AVIATION INVESTIGATION REPORT

A00H0002

LOSS OF SEPARATION

NAV CANADA
GANDER AREA CONTROL CENTRE
SYDNEY, NOVA SCOTIA 95 NM N
11 APRIL 2000

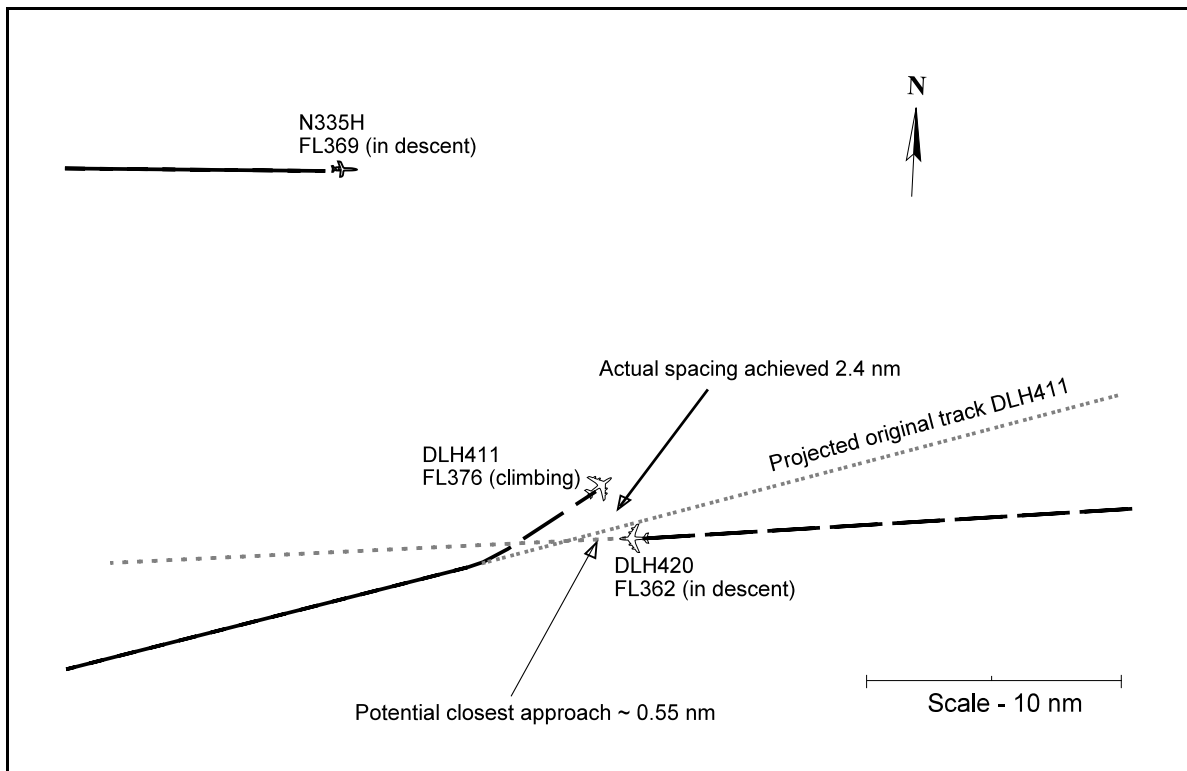
Figure 2 - Closest approach

No traffic information was provided to DLH420, and since the crew of DLH420 were on a different frequency, they did not hear the report of traffic from DLH411. DLH420 received a resolution advisory (RA) to descend when the two aircraft were approximately 15 nm apart. Since the crew had already initiated descent in accordance with the second controller's instructions, they did not report the RA; however, they increased their rate of descent. At 1851:39, the pilot of DLH411 advised the controller that he had commenced a climb as a result of a TCAS RA. Shortly thereafter he acquired the other aircraft visually. DLH420 levelled at FL360 and DLH411 reached FL376 as the aircraft passed abeam. When the aircraft had passed and the

At the time of the warning from DLH411 indicating that the two Lufthansa aircraft were 20 miles apart, they were closing at 16.5 nm per minute. By the time the second controller had issued a descent clearance to DLH420, and the pilot reported leaving FL370 at 1851:11, the aircraft were 13.6 nm apart. Recorded radar information indicates that DLH411 began a turn when the two aircraft were 11 nm apart, and DLH420 showed a descent out of FL370 when they were 8.5 nm apart. The 20-degree left turn for DLH411 was sufficient to achieve a 2.4-nm lateral spacing between the two aircraft as they passed; however, the turn did not provide sufficient spacing to prevent a TCAS RA from being triggered in each aircraft. The climb by DLH411 and the descent by DLH420 provided vertical spacing of 1400 feet at the point of closest approach.
